Massachusetts Office on Disability

This report is a follow up to the site visit conducted on September 13, 2012 of Whitman Park located in Whitman. At your request, a site visit was conducted to assist you in identifying the current architectural barriers that persons with disabilities encounter when visiting this historic park. This report shows that several aspects of the park have inaccessible features including routes to programs such as the playground, picnic area, ball parks, basketball court, exterior and interior paths, and band stand. It is our understanding that significant improvements have been made to the park including the installation of new curbing, curb cuts, lighting, seating, plantings, waste management, ball park improvements, pond retention wall and fountain mechanics, and the installation of stairs to the bandstand to which the total amounts to over \$500,000 in costs. This report cites the 2006 revision of 521 CMR enforced by the Architectural Access Board as well as the federal ADAAG with the assumption, based on newspaper articles and your assertions, that the new work performed was started in 2007.

Play and Picnic Area

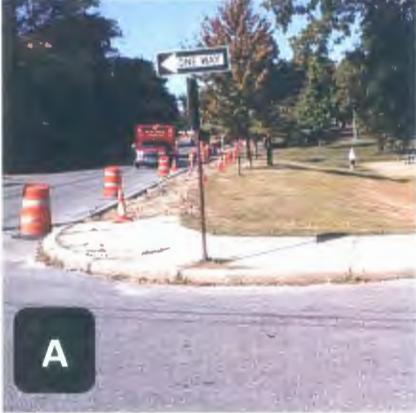
<p>A</p> <p>No curb cut / curbwork shown</p>

Current Conditions/Location	521 CMR Rev. 2006 (AAB)	ADAAG	Pictures
<p><i>Curb Cut / Play area</i> – No curb cut near play area at Maple and Whitman. Curb reconstruction is underway the length of Whitman Ave. There is no evidence of plans for a curb cut. The closest curb cut is at Park and Maple. The distance is approximately 200’ away. (Location A)</p>	<p>21.1 - Whenever <i>sidewalks, walkways</i>, or curbs on streets and ways are <i>constructed, reconstructed, or repaired</i>, <i>curb cuts</i> are required.</p> <p>23.3.1 <i>Accessible</i> parking spaces serving a particular <i>building, facility</i> or temporary event shall be located on the shortest <i>accessible route</i> of travel from adjacent parking to an <i>accessible entrance</i>.</p>	<p>4.7.1 Location – Curb ramps complying with 4.7 shall be provided wherever an accessible route crosses a curb.</p> <p>NOTE: This curb cut needs to be brought up to the ADA standards to ensure programmatic access.</p>

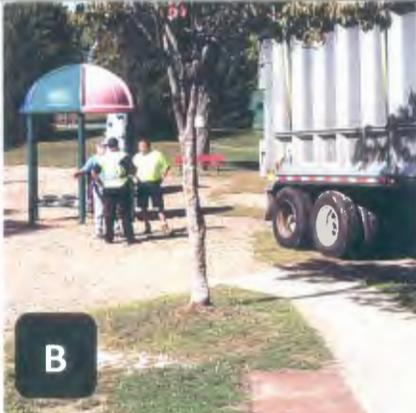
<p><i>Accessible Route/Play area</i>– The route to the playground stops at the mulch line and does not provide an accessible path of travel to any of the playground equipment. (Location B)</p>	<p>20.1 - An <i>accessible route</i> shall provide a continuous unobstructed path connecting <i>accessible spaces and elements</i> inside and outside a <i>facility</i>.</p> <p>19.7 - An <i>accessible route</i>, complying with 521 CMR 20.00: ACCESSIBLE ROUTE shall be provided to reach playground equipment and around the playground.</p>

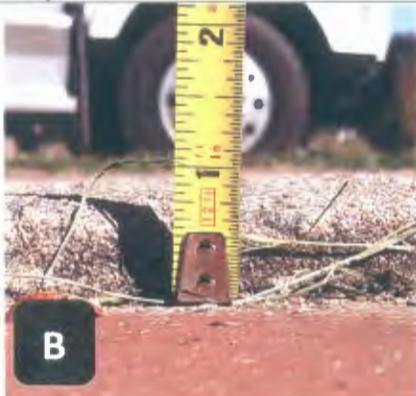
<p>B</p> <p>Play area route / sidewalk trans.</p>

<p>B</p> <p>Play area route</p>
<p><i>Accessible Route/Play area</i>– There is a change in level from sidewalk to playground path that is 3/4” with no ramp. (Location B)</p>	<p>29.2.3 - Changes in <i>level</i> greater than 1/2 inch (1/2" = 13mm) are not allowed unless a <i>ramp, walkway</i>, or means of vertical access complying with 521 CMR is provided.</p>

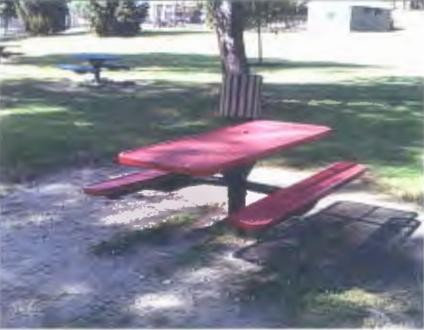
Current Conditions/Location	521 CMR Rev. 2006 (AAB)	ADAAG	Pictures
<p><i>Accessible Route/Picnic area</i>— There is no accessible route to the picnic tables.</p> <p><i>Accessible Route/Picnic area</i>— There is no accessible route to the waste receptacles.</p>	<p>20.1 GENERAL - An <i>accessible route</i> shall provide a continuous unobstructed path connecting <i>accessible spaces</i> and <i>elements</i> inside and outside a <i>facility</i>. <i>Accessible routes</i> may include but are not limited to <i>walks</i>, halls, corridors, aisles, skywalks, and tunnels. <i>Accessible routes</i> may not include stairs, steps, or escalators, even if the stairs and steps are required to be <i>accessible</i> under 521 CMR.</p> <p>20.8 SURFACE TEXTURES The surface of an <i>accessible route</i> shall comply with 521 CMR 29.00: FLOOR SURFACES.</p>

<p>Picnic tables and waste receptacle</p>
<p><i>Tables /Picnic area</i>— There are no accessible picnic tables out of the six picnic tables provided in this area.</p>	<p>19.6.2 Tables: At least 5% of tables, where provided shall be <i>accessible</i> and shall comply with 521 CMR 19.5.2.</p> <p>19.5.2 Tables: At least 5% of tables shall be <i>accessible</i>. Tables for the <i>accessible sites</i> shall provide <i>clear space</i> under the table top not less than 30 inches wide (30" = 762mm) and 19 inches (19" = 483mm) deep per seating space and not less than 27 inches (27" = 686mm) <i>clear</i> from the ground to the underside of the table. See Fig. 19d.</p>

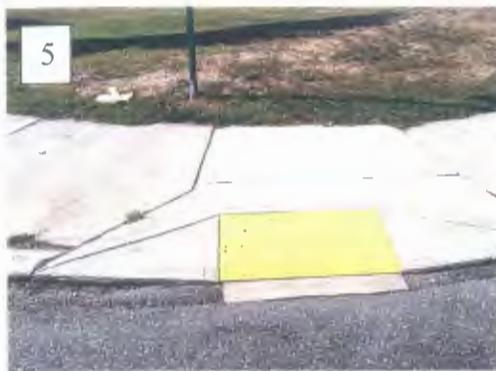
Image -5: Maple and Park Ave.

There are at least two non-compliant curb cuts located on Park Ave. The newest curb cut at the corner of Maple Ave. and Park Ave. has a non-compliant slope. The other existing curb cuts do not have compliant reciprocal curb cuts on Park Ave.

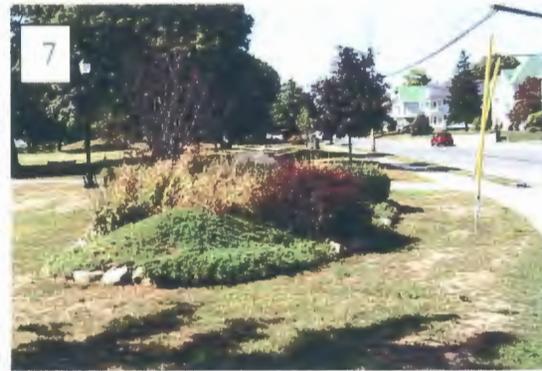
Image -7: new plantings

Improvements have been made to the east ball park area since 2007 including the reconstruction of portions of sidewalk, curbing, seating, lighting, and plantings, but little has been done to address the issue of access.

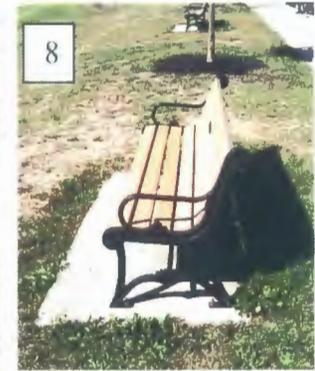
Image – 8: new benches

In addition, there is no accessible route to the baseball field or basketball court grade levels. Also, there are a series of benches along Park Ave. and interior to the park that are not accessible. The existing path that runs between the ball fields is inaccessible as well due to the surface treatment.

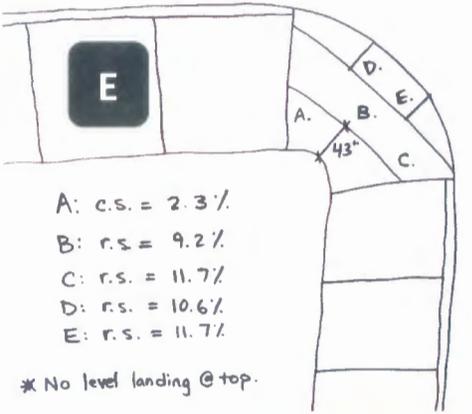
Current Conditions/Location	521 CMR Rev. 2006 (AAB)	ADAAG	Pictures
<p><i>Curb Cut / Play area</i> – Non-compliant curb cut near east ball park area at Maple and Park Ave.</p> <p>Curb cut has multiple non-compliant slopes. There is no level landing at the top of the curb cut.</p> <p>There is no reciprocal curb cut on the other side of Maple Ave. and Park Ave.</p> <p>*Note: Other non-compliant items may be present in addition to the items listed above.</p>	<p>21.2.1 <i>Curb cuts</i> are required at each corner of each intersection, located within the crosswalk and/or the pedestrian path of travel.</p> <p>21.3 The least possible slope should be used for any ramp. The maximum slope shall be one-in-12 (1:12). The maximum cross-slope for any <i>curb cut</i> shall be 1:50 (2%).</p> <p>21.6.1 Landing width: Where a perpendicular <i>curb cut</i> is provided, a landing the width of the <i>curb cut</i> shall be provided at the top of the <i>curb cut</i>. The landing shall be 48 inches (48"= 1219mm) in length. The slope of said landing shall not exceed one-in-50 (1:50) (2%) in any direction.</p> <p>*Note: Other regulations do apply in addition to the regulations listed above.</p>	<p>4.7.1 Location – Curb ramps complying with 4.7 shall be provided wherever an accessible route crosses a curb.</p> <p>4.7.2 Slope – Slopes of curb ramps shall comply with 4.8.2.</p> <p>4.8.2 Slope and Rise – The least possible slope shall be used for any ramp. The maximum slope of a ramp in new construction shall be 1:12. The maximum rise for any run shall be 30 in.</p>

<p>A: c.s. = 2.3% B: r.s. = 9.2% C: r.s. = 11.7% D: r.s. = 10.6% E: r.s. = 11.7%</p> <p>* No level landing @ top.</p>

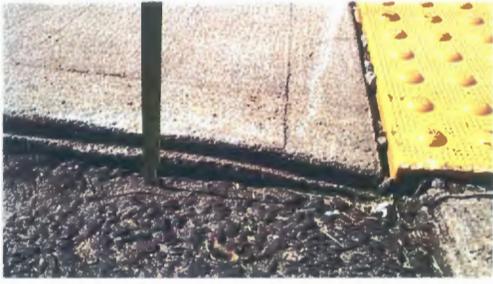
<p>Non-compliant curb cut</p>

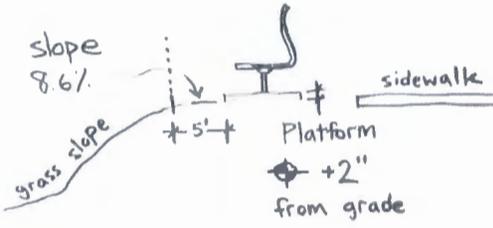
<p><i>Seating / Along Park Ave.</i> Benches provided along sidewalk are not accessible due to change in level or raised concrete platform. There is no maneuvering space on the platform. There is a sudden slope at the front of the bench.</p>	<p>20.1 An <i>accessible route</i> shall provide a continuous unobstructed path connecting <i>accessible spaces</i> and <i>elements</i> inside and outside a <i>facility</i>.</p> <p>29.2.3 Changes in <i>level</i> greater than ½ inch (½" = 13mm) are not allowed unless a <i>ramp</i>, <i>walkway</i>, or means of vertical access complying with 521 CMR is provided.</p>

<p>slope 8.6% grass slope + 5' + Platform + 2" from grade sidewalk</p> <p>Baseball spectator benches.</p>

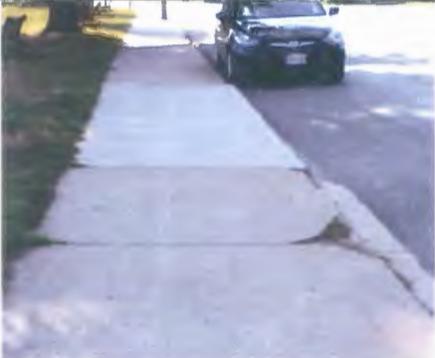
Current Conditions/Location	521 CMR Rev. 2006 (AAB)	ADAAG	Pictures
<p><i>Sidewalk surface/ Park Ave.</i> Sidewalk is broken in multiple locations with changes in height greater than ¼".</p> <p>Sidewalk sections in multiple locations have been recently renovated.</p>	<p>29.2.2 Changes in <i>level</i> greater than ¼ inch (¼" = 6mm) and less than ½ inch (½" = 13mm) shall be beveled with a slope no greater than one-in-two (1:2) (50%). See Fig. 29a.</p> <p>29.2.3 Changes in <i>level</i> greater than ½ inch (½" = 13mm) are not allowed unless a <i>ramp, walkway</i>, or means of vertical access complying with 521 CMR is provided.</p>

<p>Broken sidewalk on Park Ave.</p>
<p><i>Accessible Route / E. Ball Park</i> The route through the park has an inaccessible surface in multiple locations. The surface is loosely packed and not firm in multiple locations.</p>	<p>29.1 Ground and floor surfaces including floors, <i>walks, ramps</i>, and <i>curb cuts</i> shall be stable, firm, slip resistant, and maintained with materials that ensure continued slip resistance.</p>

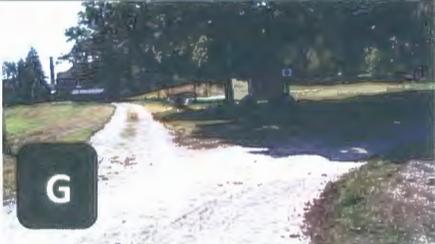
<p>Loosely packed surface at location G.</p>

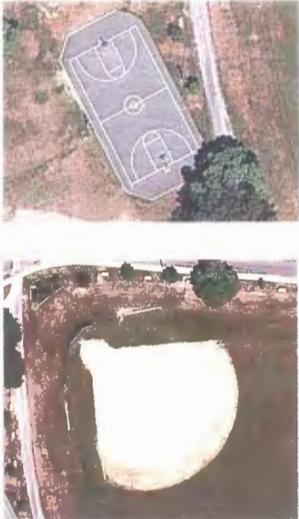
<p><i>Ball field & ball court</i> These playing areas do not have an accessible route to the boundary of each.</p>	<p>20.1 - An <i>accessible route</i> shall provide a continuous unobstructed path connecting <i>accessible spaces</i> and <i>elements</i> inside and outside a <i>facility</i>.</p>

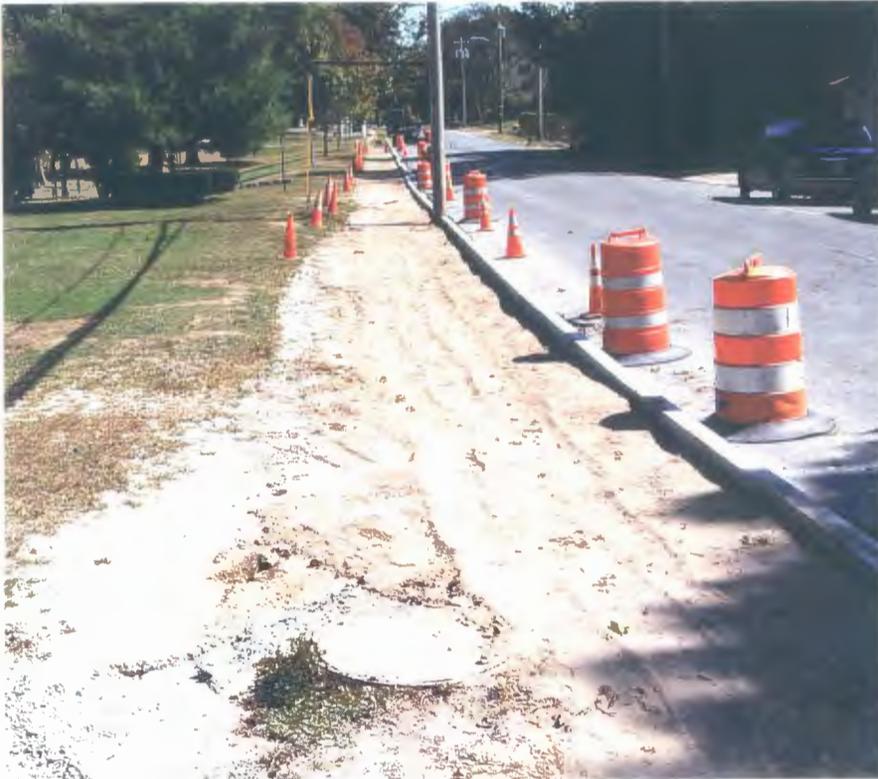
Curb cut construction on Whitman Ave.

On the southern border of the park at Whitman Ave. the curb is currently being replaced by new curb stones. It is unknown whether an accessible sidewalk is planned. An accessible route should connect all programs along this edge of the park.

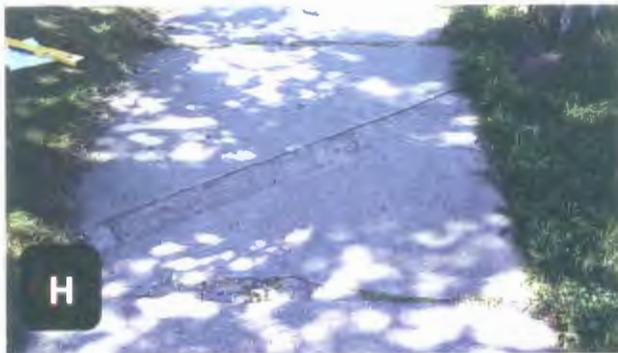
Sidewalk at location H

There are multiple locations where new sidewalk has been added, however, there are other spaces where the sidewalk is in disrepair with changes in level greater than 1/4". A full audit of these locations should be done and modifications made.

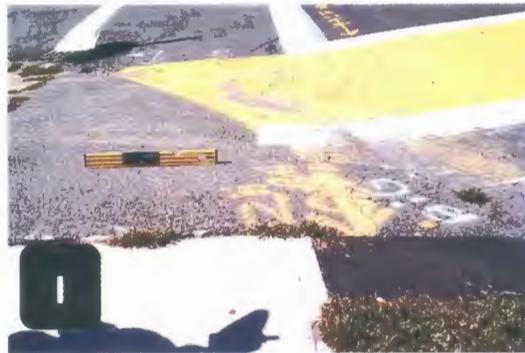
Curb cut at location I

Curb cuts at the corners of Park Ave and Hyden Ave and Whitman Ave and Hyden Ave are non-compliant. These curb cuts should be reconstructed to comply with AAB and AADAG with compliant crossings to reciprocal curbcuts.

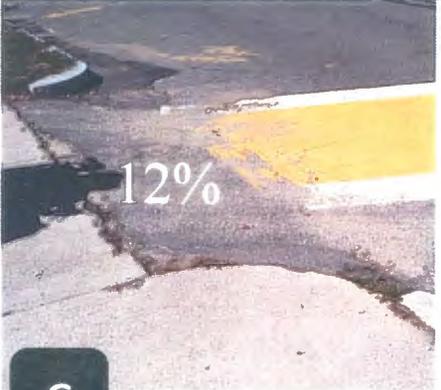
Current Conditions/Location	521 CMR Rev. 2006 (AAB)	ADAAG	Pictures																				
<p><i>Accessible Route/Park Ave. Crossing</i>—The slope of this curb cut is 12%. The transition from curb cut apron to sidewalk has a break in surface greater than and a change in level greater than 1/2". There is also evidence of drainage problems. Washout debris presents a hazard to surface conditions.</p> <p>Note: New curbing runs along Park Ave. from Hayden Ave. to this location.</p>	<p>21.3 The least possible slope should be used for any ramp. The maximum slope shall be one-in-12 (1:12 = 8.33%). The maximum cross-slope for any <i>curb cut</i> shall be 1:50 (2%).</p> <p>21.4 TRANSITIONS Transitions from <i>curb cuts</i> to <i>walks</i>, gutters, or streets shall be flush or free of changes in <i>level</i> greater than 1/2 inch (1/2" = 13mm).</p> <p>22.5 SURFACE - <i>Walkway</i> surfaces shall be stable and firm and shall lie generally in a continuous plane with a minimum of surface warping.</p>	<p>4.5 General. Ground and floor surfaces along accessible routes and in accessible rooms and spaces including floors, walks, ramps, stairs, and curb ramps, shall be stable firm, slip-resistant, and shall comply with 4.5</p>

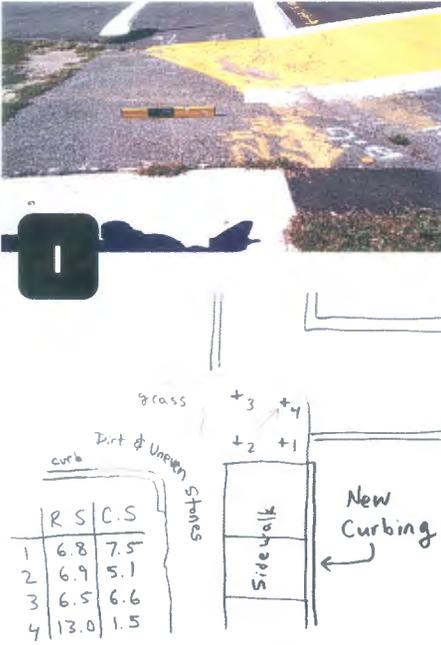
<p><i>Accessible Route/Park Ave. Crossing</i>—The cross slopes of this curb cut are non-compliant. The sidewalk ends and the walkway is continued by stone and dirt path along Hayden Street.</p> <p>Note: New curbing runs along Park Ave. from this location to curb cut at location G.</p>	<p>21.3 The least possible slope should be used for any ramp. The maximum slope shall be one-in-12 (1:12 = 8.33%). The maximum cross-slope for any <i>curb cut</i> shall be 1:50 (2%).</p> <p>22.5 SURFACE - <i>Walkway</i> surfaces shall be stable and firm and shall lie generally in a continuous plane with a minimum of surface warping.</p>	<p>4.5 General. Ground and floor surfaces along accessible routes and in accessible rooms and spaces including floors, walks, ramps, stairs, and curb ramps, shall be stable firm, slip-resistant, and shall comply with 4.5</p>

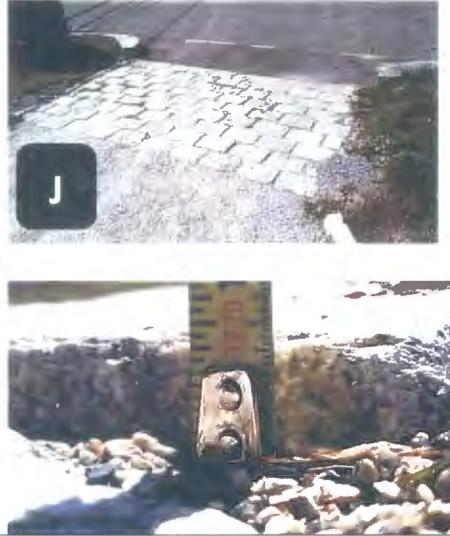
Current Conditions/Location	521 CMR Rev. 2006 (AAB)	ADAAG	Pictures
<p><i>Access. Route/Hayden Ave. Crossing</i>— This curb cut is made up of granite paving blocks. There are gaps between blocks greater than ½” in running and cross directions, deeper than 1/2” and the surface is uneven.</p> <p>Note: This curb cut was just installed summer of 2012.</p>	<p>29.2.3 Changes in level greater than ½ inch (½" = 13mm) are not allowed unless a ramp, walkway, or means of vertical access complying with 521 CMR is provided.</p> <p>22.5 SURFACE - Walkway surfaces shall be stable and firm, and shall lie generally in a continuous plane with a minimum of surface warping.</p>	<p><i>2010 ADA Standards</i> 302.3 Openings. Openings in floor or ground surfaces shall not allow passage of a sphere more than ½” diameter.</p>

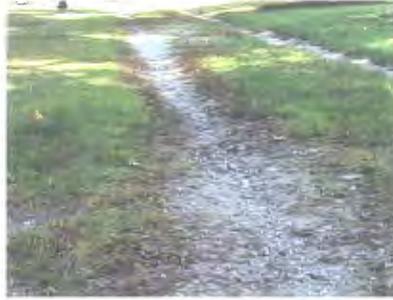
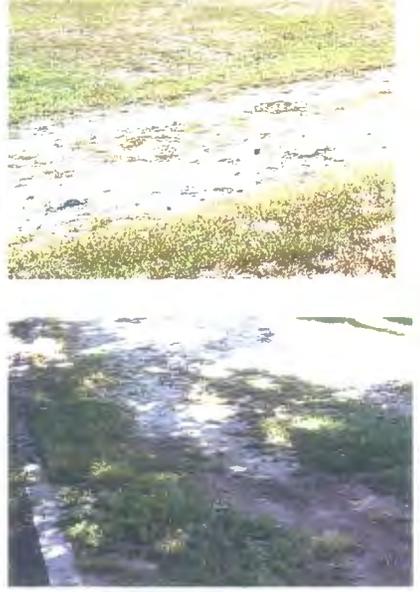
<p><i>Accessible Route Interior</i> The route through the park has an inaccessible surface in multiple locations. The surface is loosely packed and not firm in multiple locations. Persons using wheelchairs have gotten snagged in soft and deep areas of stone surfacing.</p>	<p>29.1 Ground and floor surfaces including floors, walks, ramps, and curb cuts shall be stable, firm, slip resistant, and maintained with materials that ensure continued slip resistance.</p>

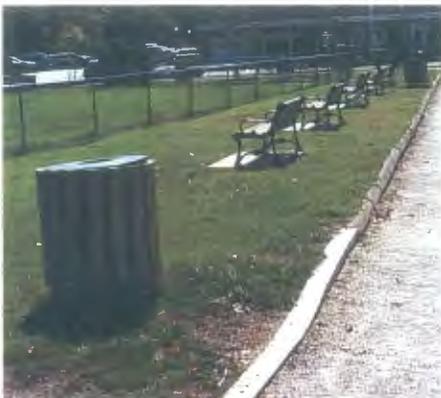
Image -1: new waste receptacle

Waste receptacles are placed off of the path and out of reach range with no maneuvering space around them.

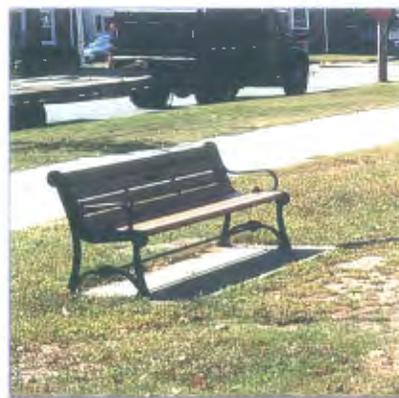
Image -2: new bench

The seating benches are placed with no accessible route off of the interior paths. There is no level landing with adequate maneuvering space and the existing landing is often located with a change in level greater than 1/2”.

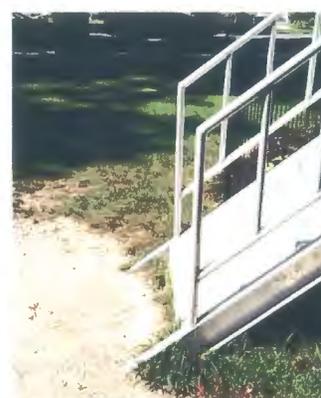
Image -3: gazebo stairs

The band stand gazebo does not provide accessible vertical access. The stairs that are present are also non-compliant stairs with less than the minimum requirements for handrail extensions.

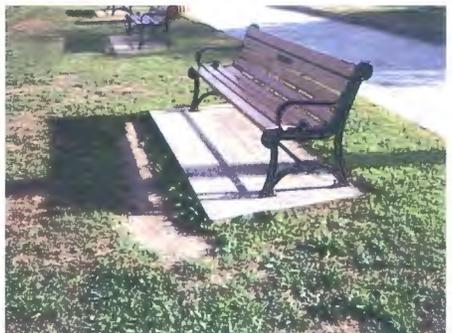
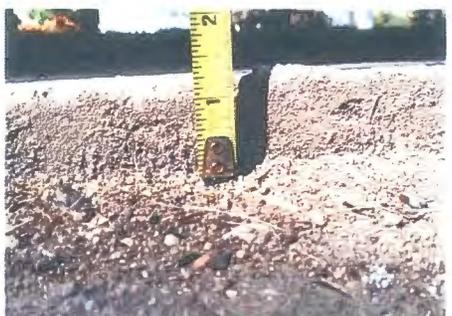
Current Conditions/Location	521 CMR Rev. 2006 (AAB)	ADAAG	Pictures
<p><i>Seating / by Ballpark & Pond</i> Benches provided along pond and baseball park are not accessible due to change in level or raised concrete platform. There is no maneuvering space on the platform. Curbing prevents access to benches also.</p>	<p>20.1 An <i>accessible route</i> shall provide a continuous unobstructed path connecting <i>accessible spaces</i> and <i>elements</i> inside and outside a <i>facility</i>.</p> <p>29.2.3 Changes in <i>level</i> greater than ½ inch (½" = 13mm) are not allowed unless a <i>ramp</i>, <i>walkway</i>, or means of vertical access complying with 521 CMR is provided.</p> <p>14.2 No. of Accessible Seats Wheelchair spaces: In places of assembly with fixed seating, the minimum number of <i>accessible spaces</i> shall be computed in accordance with table in 14.2</p>	<p>4.32.1 Minimum Number – Fixed or built-in seating or tables required to be accessible by 4.1 shall comply with 4.32 and 4.33</p> <p>4.33.2 Each wheelchair location shall provide minimum clear ground or floor spaces as shown in Fig. 46.</p> <p>4.33.3 Placement of Wheelchair locations – Wheelchair areas shall be an integral part of any fixed seating plan...</p> <p>4.33.4 Surfaces – The ground or floor at wheelchair locations shall be level and shall comply with 4.5</p>

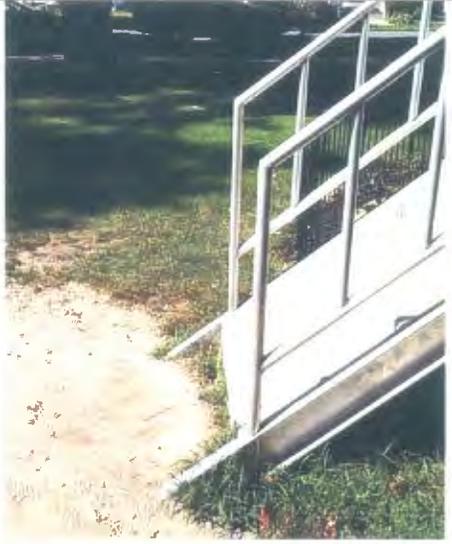
<p><i>Gazebo Vertical Access</i> There is no accessible vertical access provided to the band stand gazebo. There has been a new set of stairs installed replacing an old set of stairs.</p> <p><i>Gazebo Handrails</i> There are no extensions on the installed stair handrails.</p>	<p>20.1 GENERAL. An <i>accessible route</i> shall provide a continuous unobstructed path connecting <i>accessible spaces</i> and <i>elements</i> inside and outside a <i>facility</i>...<i>Accessible routes</i> may not include stairs, steps, or escalators, even if the stairs and steps are required to be <i>accessible</i> under 521 CMR.</p> <p>27.4.3 Extensions: Where handrails terminate at the top and bottom of a stair run, they shall have extensions...</p>

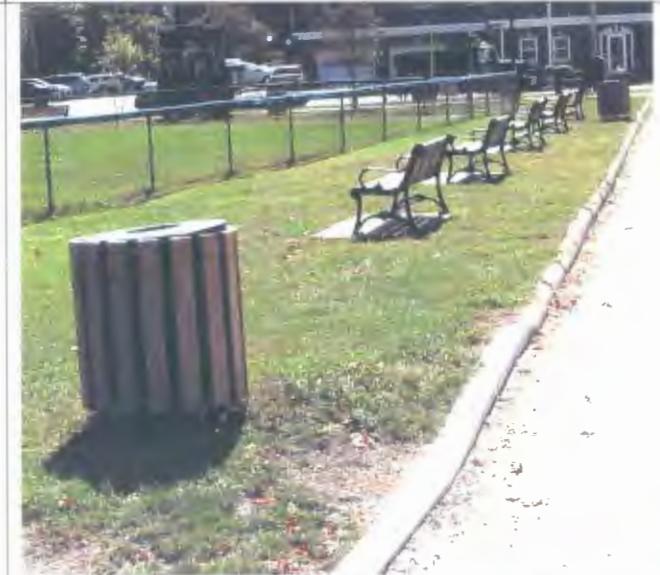
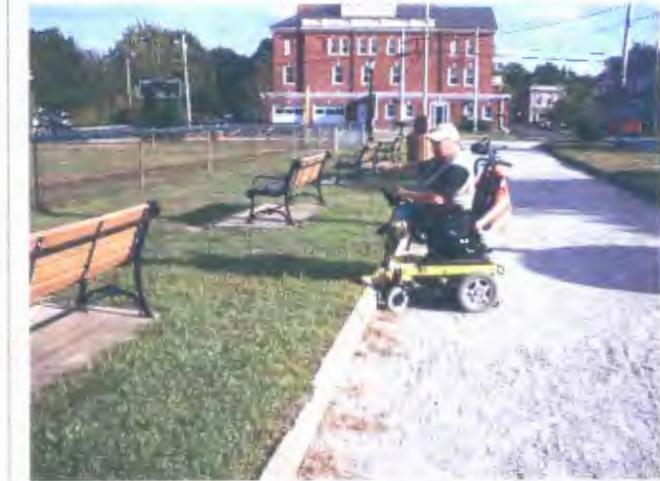
Waste Receptacles/Reach Range
 Most, if not all, of the waste receptacles that have been recently installed are not located on an accessible route.

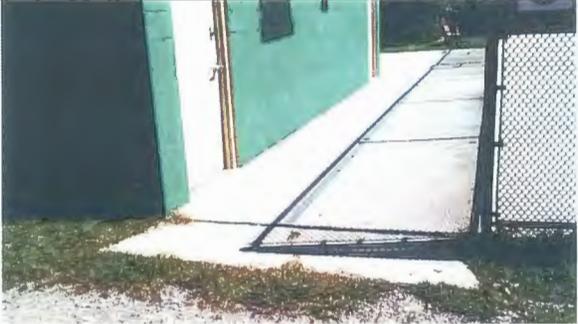
Current Conditions/Location	521 CMR Rev. 2006 (AAB)	Current ADAAG	Pictures
<p><i>Accessible Route/Pool area-</i> The route to the pool is separated by a strip of grass from the concrete platform which accesses the pool and changing rooms.</p>	<p>20.1 - An <i>accessible route</i> shall provide a continuous unobstructed path connecting <i>accessible spaces</i> and <i>elements</i> inside and outside a <i>facility</i>.</p>

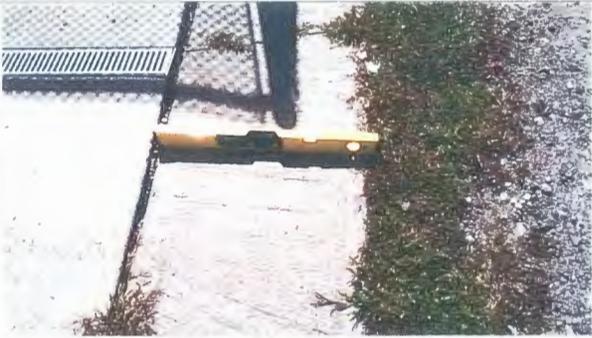
<p><i>Accessible Route/Pool area-</i> There is a non-compliant slope of 12% at the entry to the concrete platform.</p>	<p>21.3 The least possible slope should be used for any ramp. The maximum slope shall be one-in-12 (1:12 = 8.33%). The maximum cross-slope for any <i>curb cut</i> shall be 1:50 (2%).</p>
