Massachusetts Office on Disability

This report is a follow up to the site visit conducted on September 13, 2012 of Whitman Park located in Whitman. At your request, a site visit was conducted to assist you in identifying the current architectural barriers that persons with disabilities encounter when visiting this historic park. This report shows that several aspects of the park have inaccessible features including routes to programs such as the playground, picnic area, ball parks, basketball court, exterior and interior paths, and band stand. It is our understanding that significant improvements have been made to the park including the installation of new curbing, curb cuts, lighting, seating, plantings, waste management, ball park improvements, pond retention wall and fountain mechanics, and the installation of stairs to the bandstand to which the total amounts to over \$500,000 in costs. This report cites the 2006 revision of 521 CMR enforced by the Architectural Access Board as well as the federal ADAAG with the assumption, based on newspaper articles and your assertions, that the new work performed was started in 2007.

Play and Picnic Area

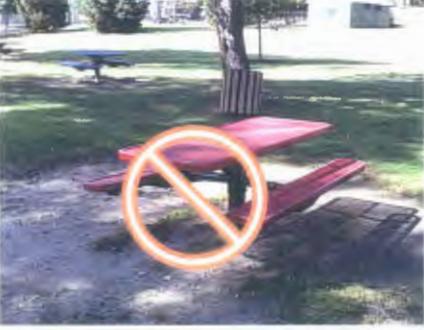
<p>Picnic tables and waste receptacle</p>
<p><i>Tables /Picnic area</i>— There are no accessible picnic tables out of the six picnic tables provided in this area.</p>	<p>19.6.2 Tables: At least 5% of tables, where provided shall be <i>accessible</i> and shall comply with 521 CMR 19.5.2.</p> <p>19.5.2 Tables: At least 5% of tables shall be <i>accessible</i>. Tables for the <i>accessible sites</i> shall provide <i>clear space</i> under the table top not less than 30 inches wide (30" = 762mm) and 19 inches (19" = 483mm) deep per seating space and not less than 27 inches (27" = 686mm) <i>clear</i> from the ground to the underside of the table. See Fig. 19d.</p>

<p>Placing a designated accessible seating location at the head of the table is considered non-compliant.</p>

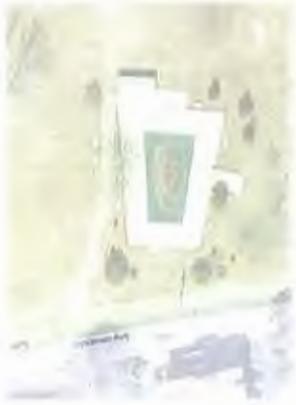
The area surrounding the pool was briefly evaluated. The changing rooms were locked and unavailable for survey at the time. The patio between the changing house and the pool fence was surveyed. There is a non-compliant change in grade between the path and this platform as shown below. A more detailed survey of the changing room and the pool itself should be done in a subsequent survey.

Current Conditions/Location	521 CMR Rev. 2006 (AAB)	Current ADAAG	Pictures
<p><i>Accessible Route/Pool area-</i> The route to the pool is separated by a strip of grass from the concrete platform which accesses the pool and changing rooms.</p>	<p>20.1 - An <i>accessible route</i> shall provide a continuous unobstructed path connecting <i>accessible spaces</i> and <i>elements</i> inside and outside a <i>facility</i>.</p>
